## RAMVAC® Slugbuster™ Evacuation System Cleaner Comparison Study

1. To evaluate the cleaning effectiveness of *RAMVAC® Slugbuster™* evacuation line cleaner compared to a competitor product when utilized for 6 months in an active dental practice.

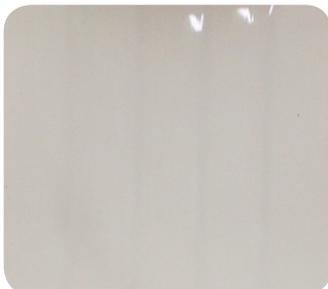
**Figure 1.** Clean, untreated evacuation line.

In a well-established dental practice, four operatories were assigned one of two evacuation line cleaning systems (*RAMVAC Slugbuster* or *Monarch Cleanstream*). New evacuation tubing was installed in each operatory prior to the initiation of the study (Figure 1). Participating dental staff were provided with test evacuation line cleaning material the associated mixing/dispensing system, and instructed on use of each cleaning solution as per manufacturers' instructions (daily for 6 months). One-inch samples of treated evacuation lines were collected at 2, 4, and 6 months. At each time interval, test specimens were visually inspected and photographed.

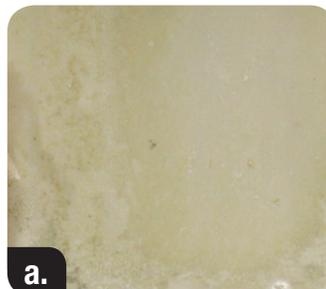
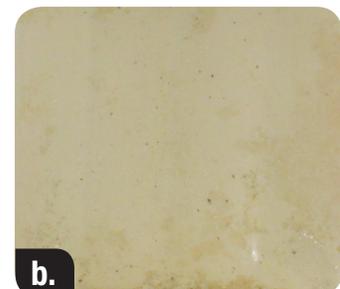
**Figure 2.** Representative photos of evacuation lines treated for 2 months, a. *RAMVAC Slugbuster* b. *Cleanstream*

At the 2 month test period, *RAMVAC Slugbuster* and *Monarch CleanStream* performed in similar manner with little to no accumulation of organic debris (Figure 2). Performance differences were noticeable after 4 months of treatment (Figure 3). Little accumulation (less than 10%) was observed in those lines treated with *Monarch CleanStream*. At the completion of the study (6 month treatment), little to no accumulation of organic debris (less than 5%) was observed with every day use of the *RAMVAC Slugbuster* cleaning system (Figure 4).
