Handpiece Maintenance Study: Oil and Lubrication

To evaluate the ability of *Statmatic Smart 1, 2, 3 Cleaning and Care System* (SciCan) to inhibit the accumulation of debris within the internal components of the handpiece compared to competitor maintenance systems when used on substrates common to dentistry.

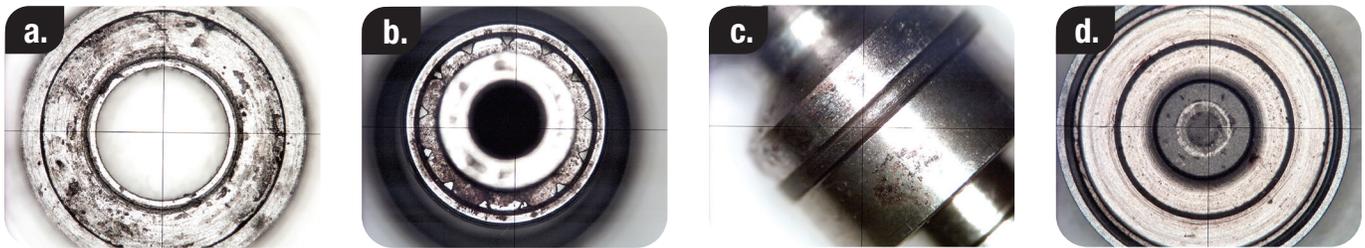
Figure 2a-d. Internal components from untreated handpiece; a) head casing, b) cartridge, c) oblique shaft assembly, and d) push button

Four internal structures were examined in order to qualify the effects of each handpiece maintenance system on the test *Sanao* handpieces; head casing, cartridge, oblique shaft assembly, and push button (Table 2). After 150 cycles of use/maintenance/sterilization, the untreated (control) handpiece demonstrated considerable surface discoloration that suggests possible debris accumulation and/or corrosion on all four internal parts examined (Figure 2a-d). Similar findings seen with the control were observed with the handpiece maintained with the *Assistina 301 Plus* (Figure 3a-d). Conversely, the handpiece maintained with *Statmatic Smart 1, 2, 3 Cleaning and Care System* (Figure 4a-d), closely resembled the internal components of an unused handpiece with the exception of one small area on the oblique shaft assembly. This surface irregularity was limited to a small grooved area, whereas multiple locations on the oblique shaft showed surface discoloration with the untreated and *Assistina 301 plus* handpieces.

After 150 cycles of simulated use on 5 hard substrates and treatment with the *Statmatic Smart 1, 2, 3 Cleaning and Care System* procedures, visual inspection of internal handpiece components revealed very little, if any, discoloration. In comparison, considerable discoloration, signifying possible debris accumulation, was noted following 150 cycles of prescribed *Assistina 301 Plus* cycles and untreated controls. Manufacturer's directions were followed for each system tested.

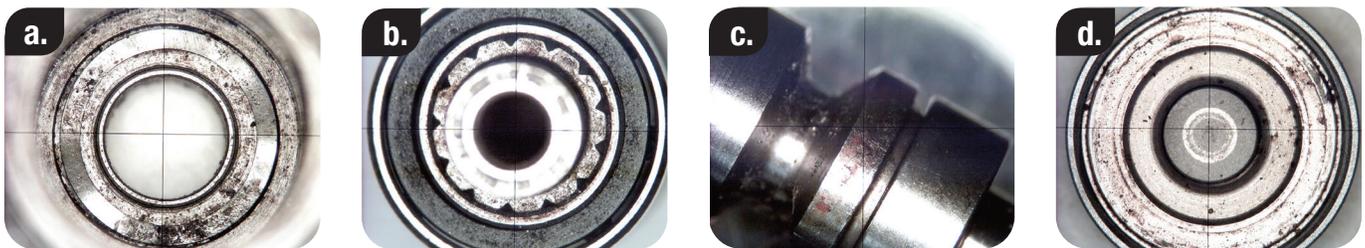
Figure 3a-d. Internal components from *Assistina 301 plus* handpiece; a) head casing, b) cartridge, c) oblique shaft assembly, and d) push button

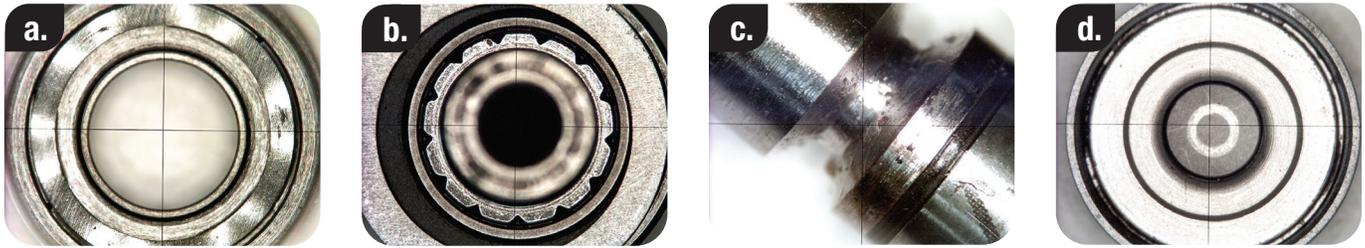
Figure 4a-d. Internal components from *Statmatic Smart 1, 2, 3 Cleaning and Care System* handpiece; a) head casing, b) cartridge, c) oblique shaft assembly, and d) push button
